June 28, 2011

Mr. Glenn Bell
Mr. Rudy Lee
Dr. Barry Jenkins
Session and Church Leaders
First Presbyterian Church
700 Park Avenue
Florence, SC 29501

RE: Facility Assessment

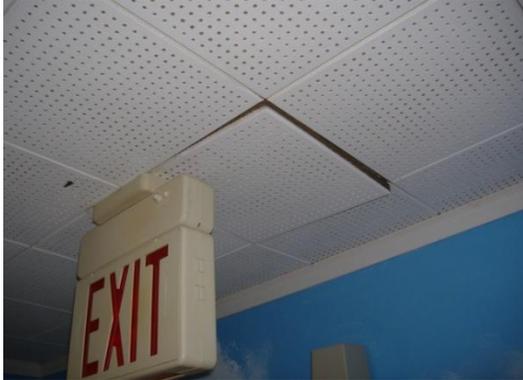
Discovery Class ceiling tile loose

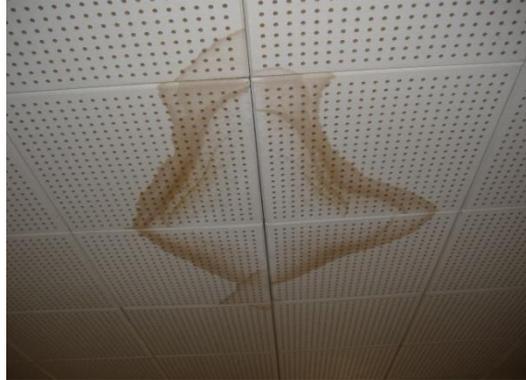
E-202 ceiling stain (roof leak)

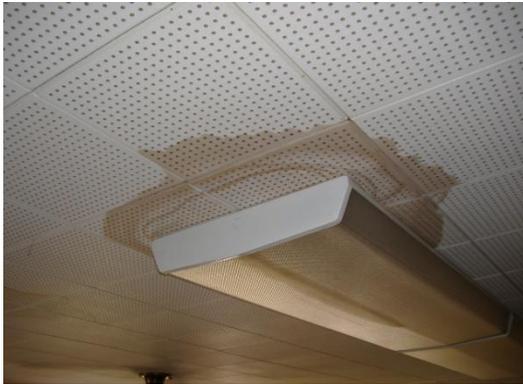
E-205 ceiling stained

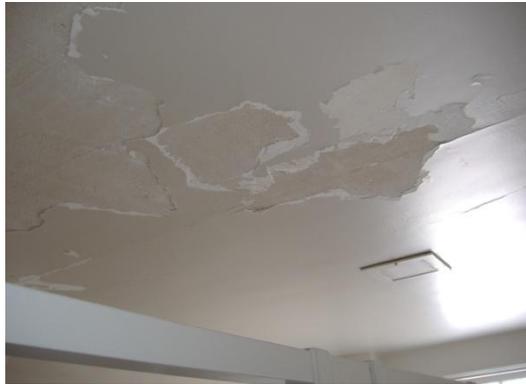
Ladies bathroom ceiling peeling

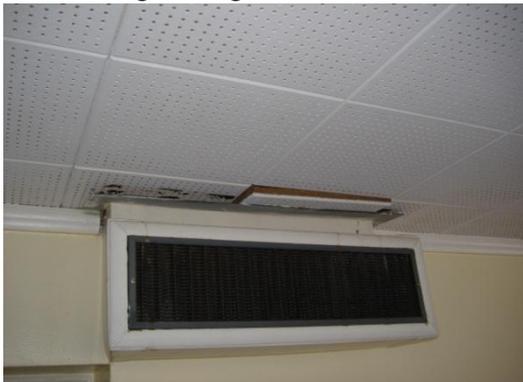
E-113 ceiling coming down

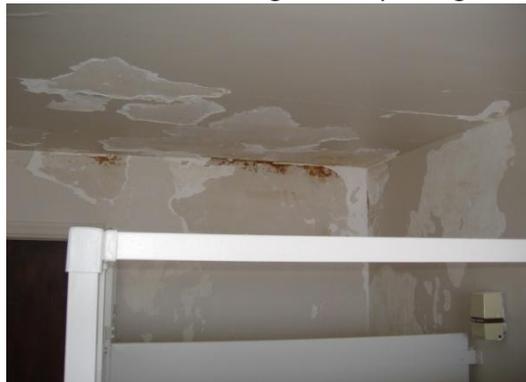
Ladies bathroom ceiling stain & peeling

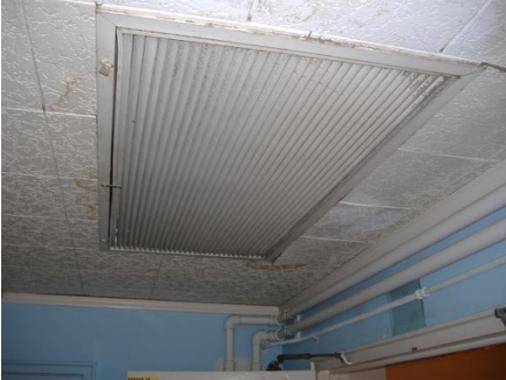
E-109 exposed piping, ceiling tile stained

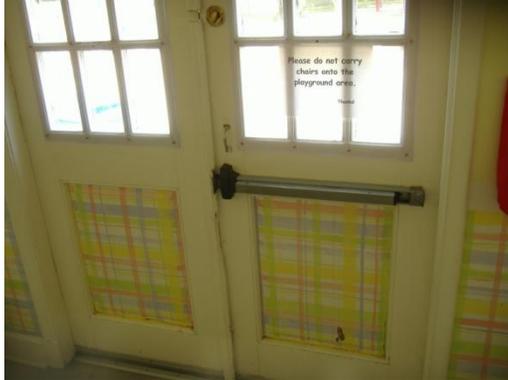
Exit door, not sealed, rotting, non-insulated

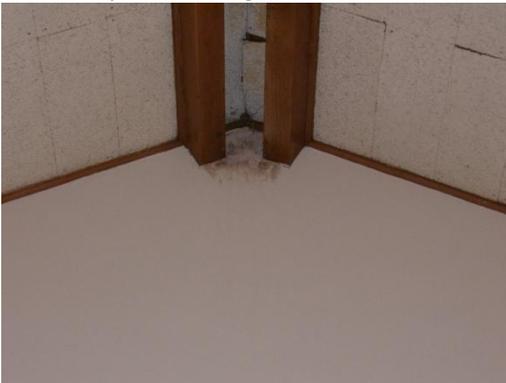
Fellowship hall ceiling cracked & water stained

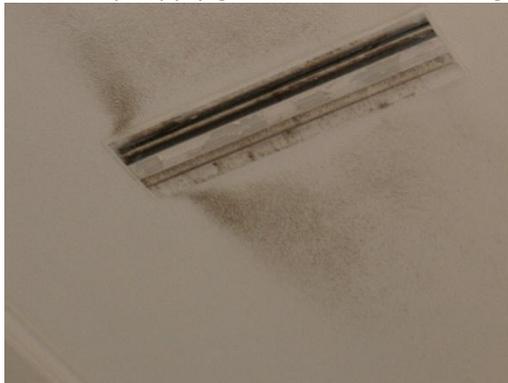
- j. Duct work lining is rotting and being blown out of the supply lines. (Appendix "B").
 - k. HVAC diffusers a very dirty and it cannot be determined if the discoloration is merely dirt/debris or mold/mildew.

Sanctuary supply grille, insulation blowing out

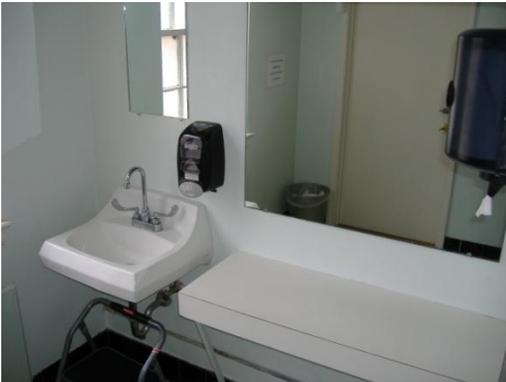
- d. Much of the tile floor is showing significant wear and we are concerned that it may contain asbestos.
 - e. Bathrooms do not comply with ADA requirements and are in need of modernization.

Men's bathroom, not handicap

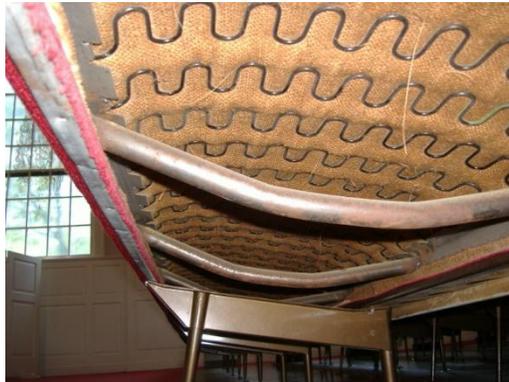
- l. Lighting in the sanctuary is in adequate with low lumens. In addition, the controls are not adequate for the use of the space.
 - m. The jute backing material that covers the inner springs of the pews is dry rotting and falling to the floor.

Bottom side of pews, padding dry-rotted

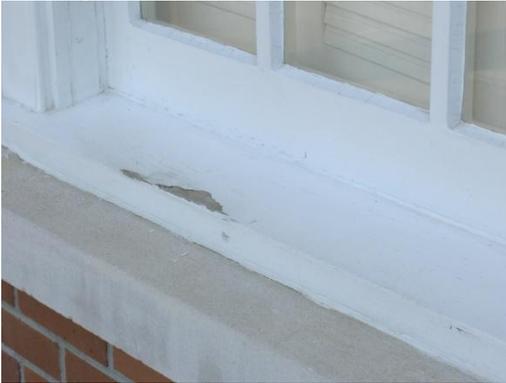
- a. Electrical system, HVAC system and plumbing are not up to new codes and requirements.
 - b. The wood framed windows are single paned glazing which are very inefficient, condensation develops regularly on the inside glass and runs down the interior walls as well as soaking into the sill, causing the wood to rot.

Building exterior window, wood rot

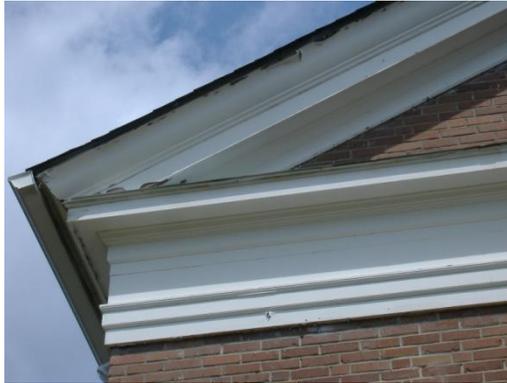
Wood rot, paint peeling

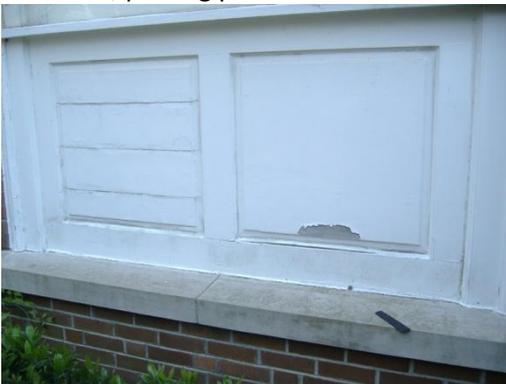
Wood rot, peeling paint

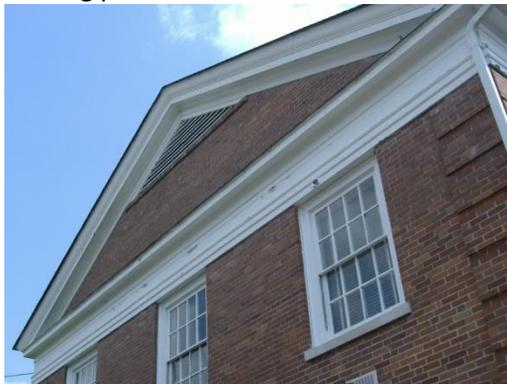
Peeling paint

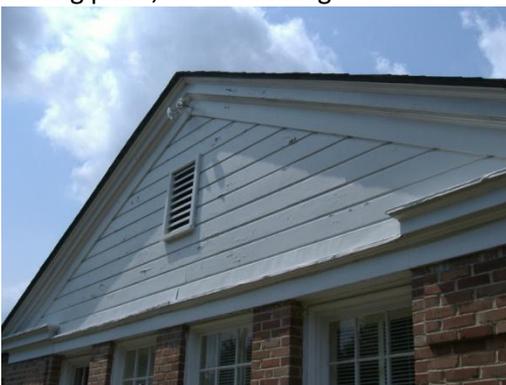
Peeling paint, dried caulking

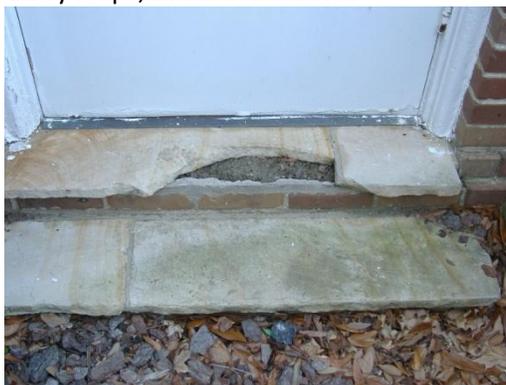
Entry steps, broken & unlevel

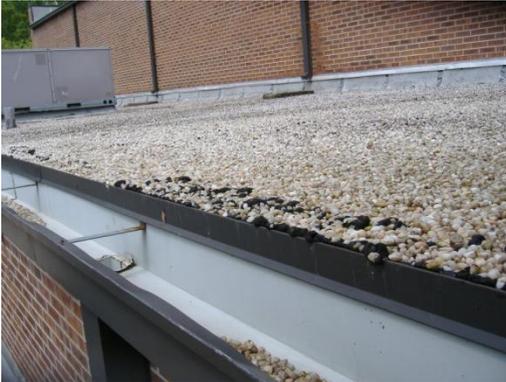
Flat roof stone is very sparse

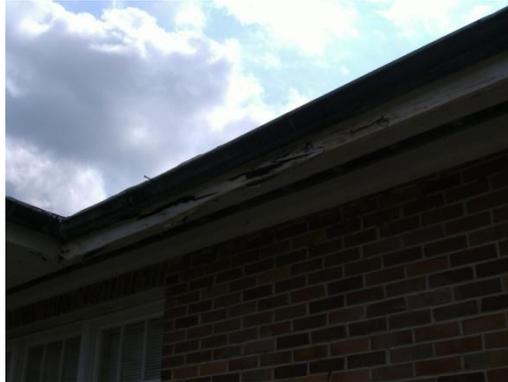
Fascia decayed

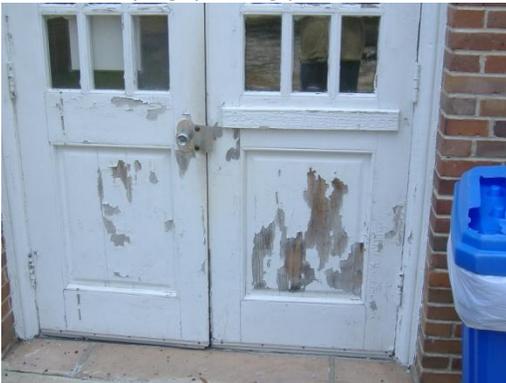
Doors decaying, peeling paint, non-insulated

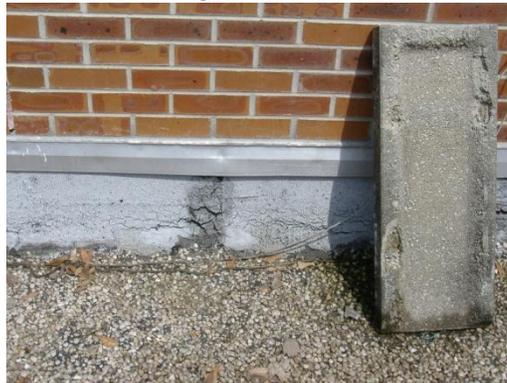
Flat roof flashing brittle & cracked

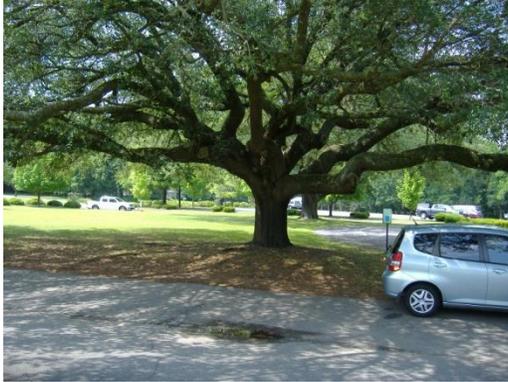
Parking lot holding water

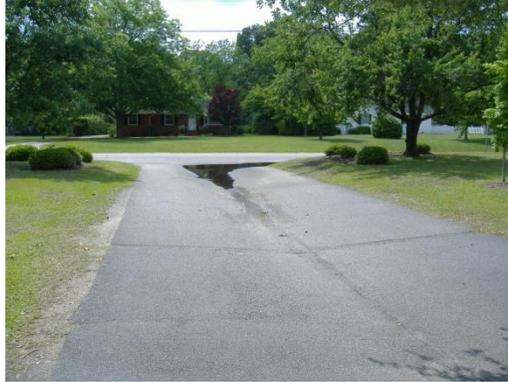
Driveway at street, holding water (ice hazard)

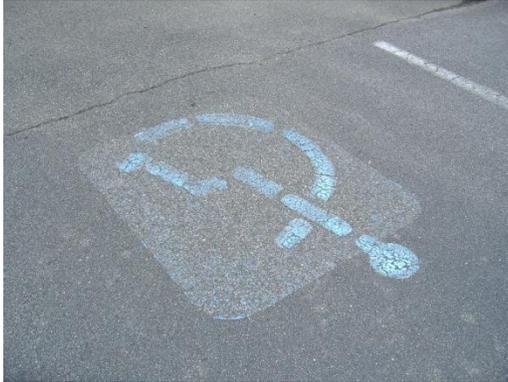
Parking lot paint faded

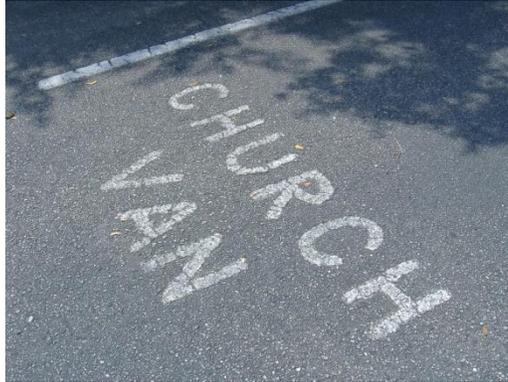
Faded paint

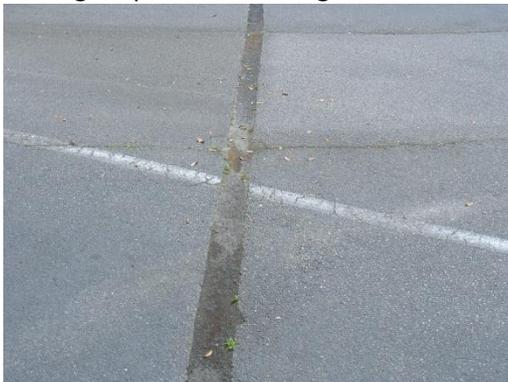
Parking lot patch & cracking

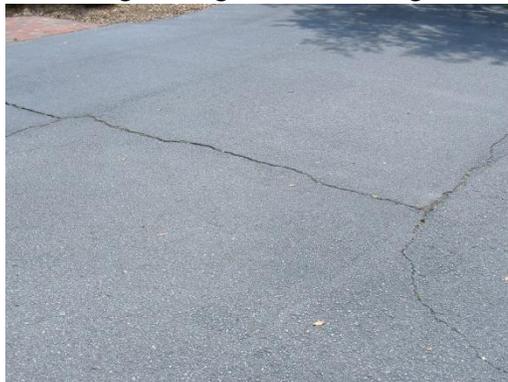
Parking lot longitudinal cracking

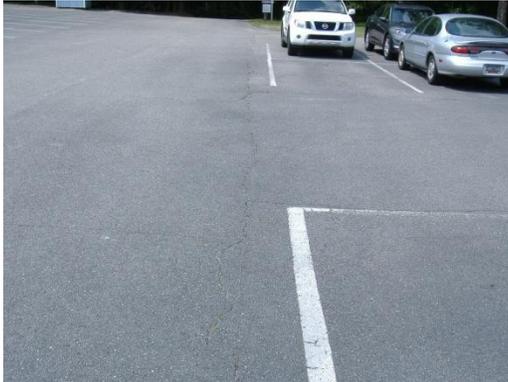
Longitudinal cracking

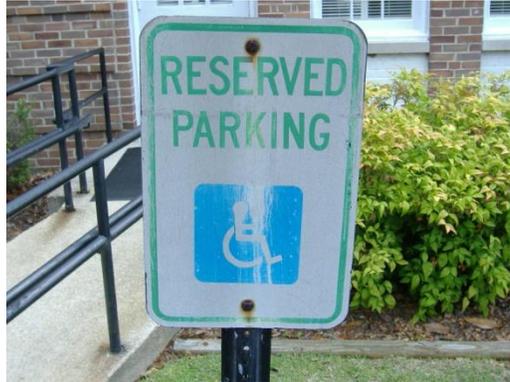
Faded signage
